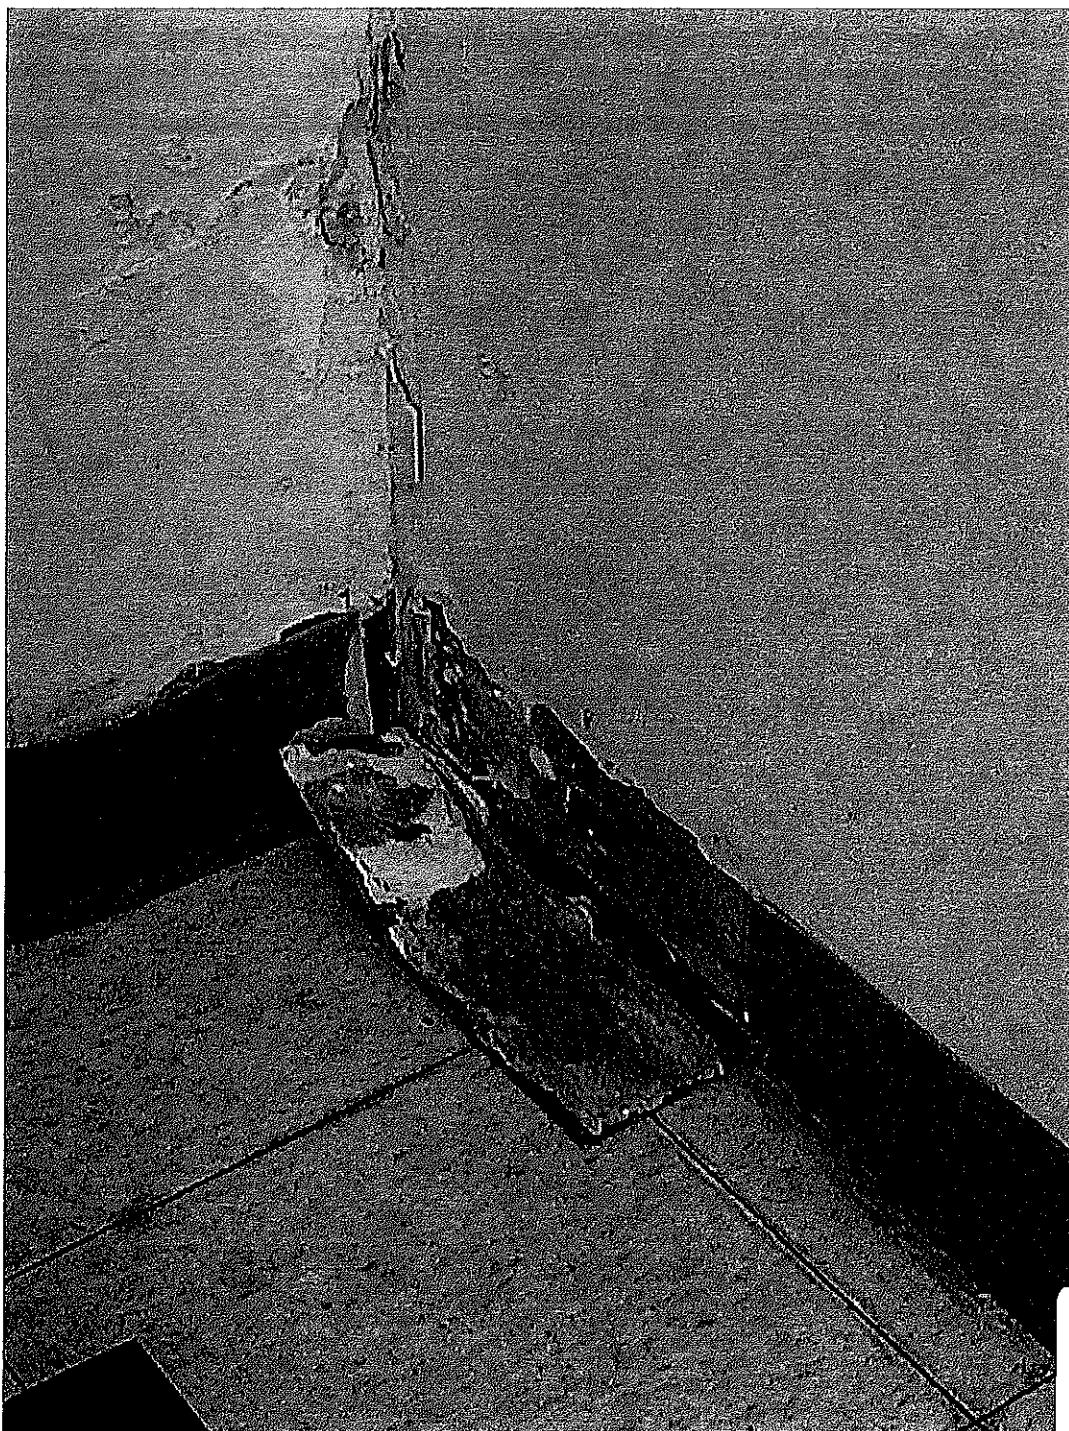
Ground level Police entrance:
Water damage, rotted sheet rock and
mold.

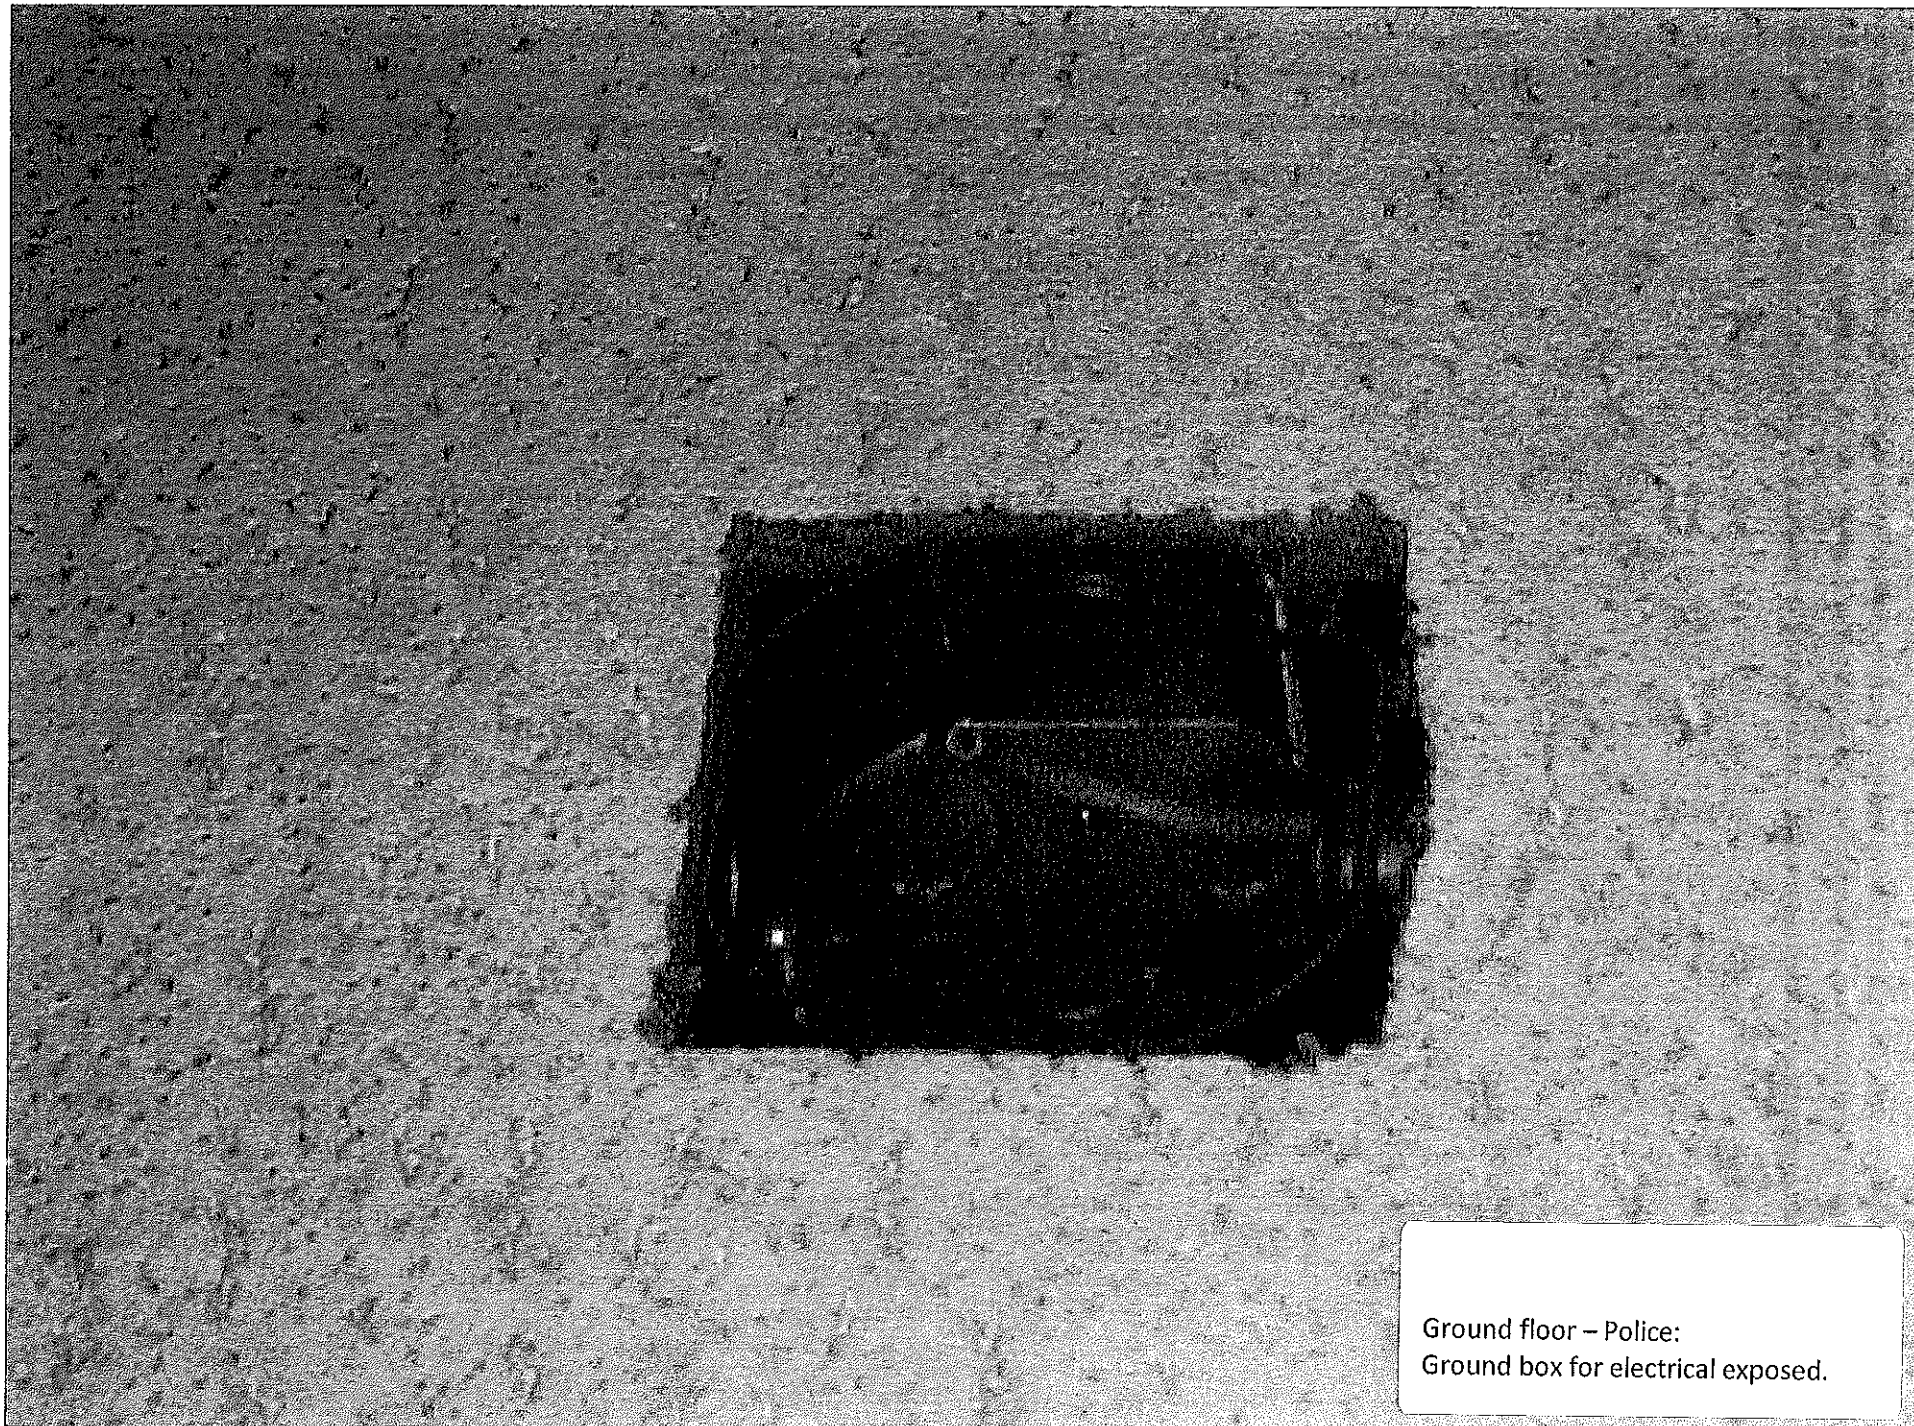
Ground floor – Police:
Ground box for electrical exposed.

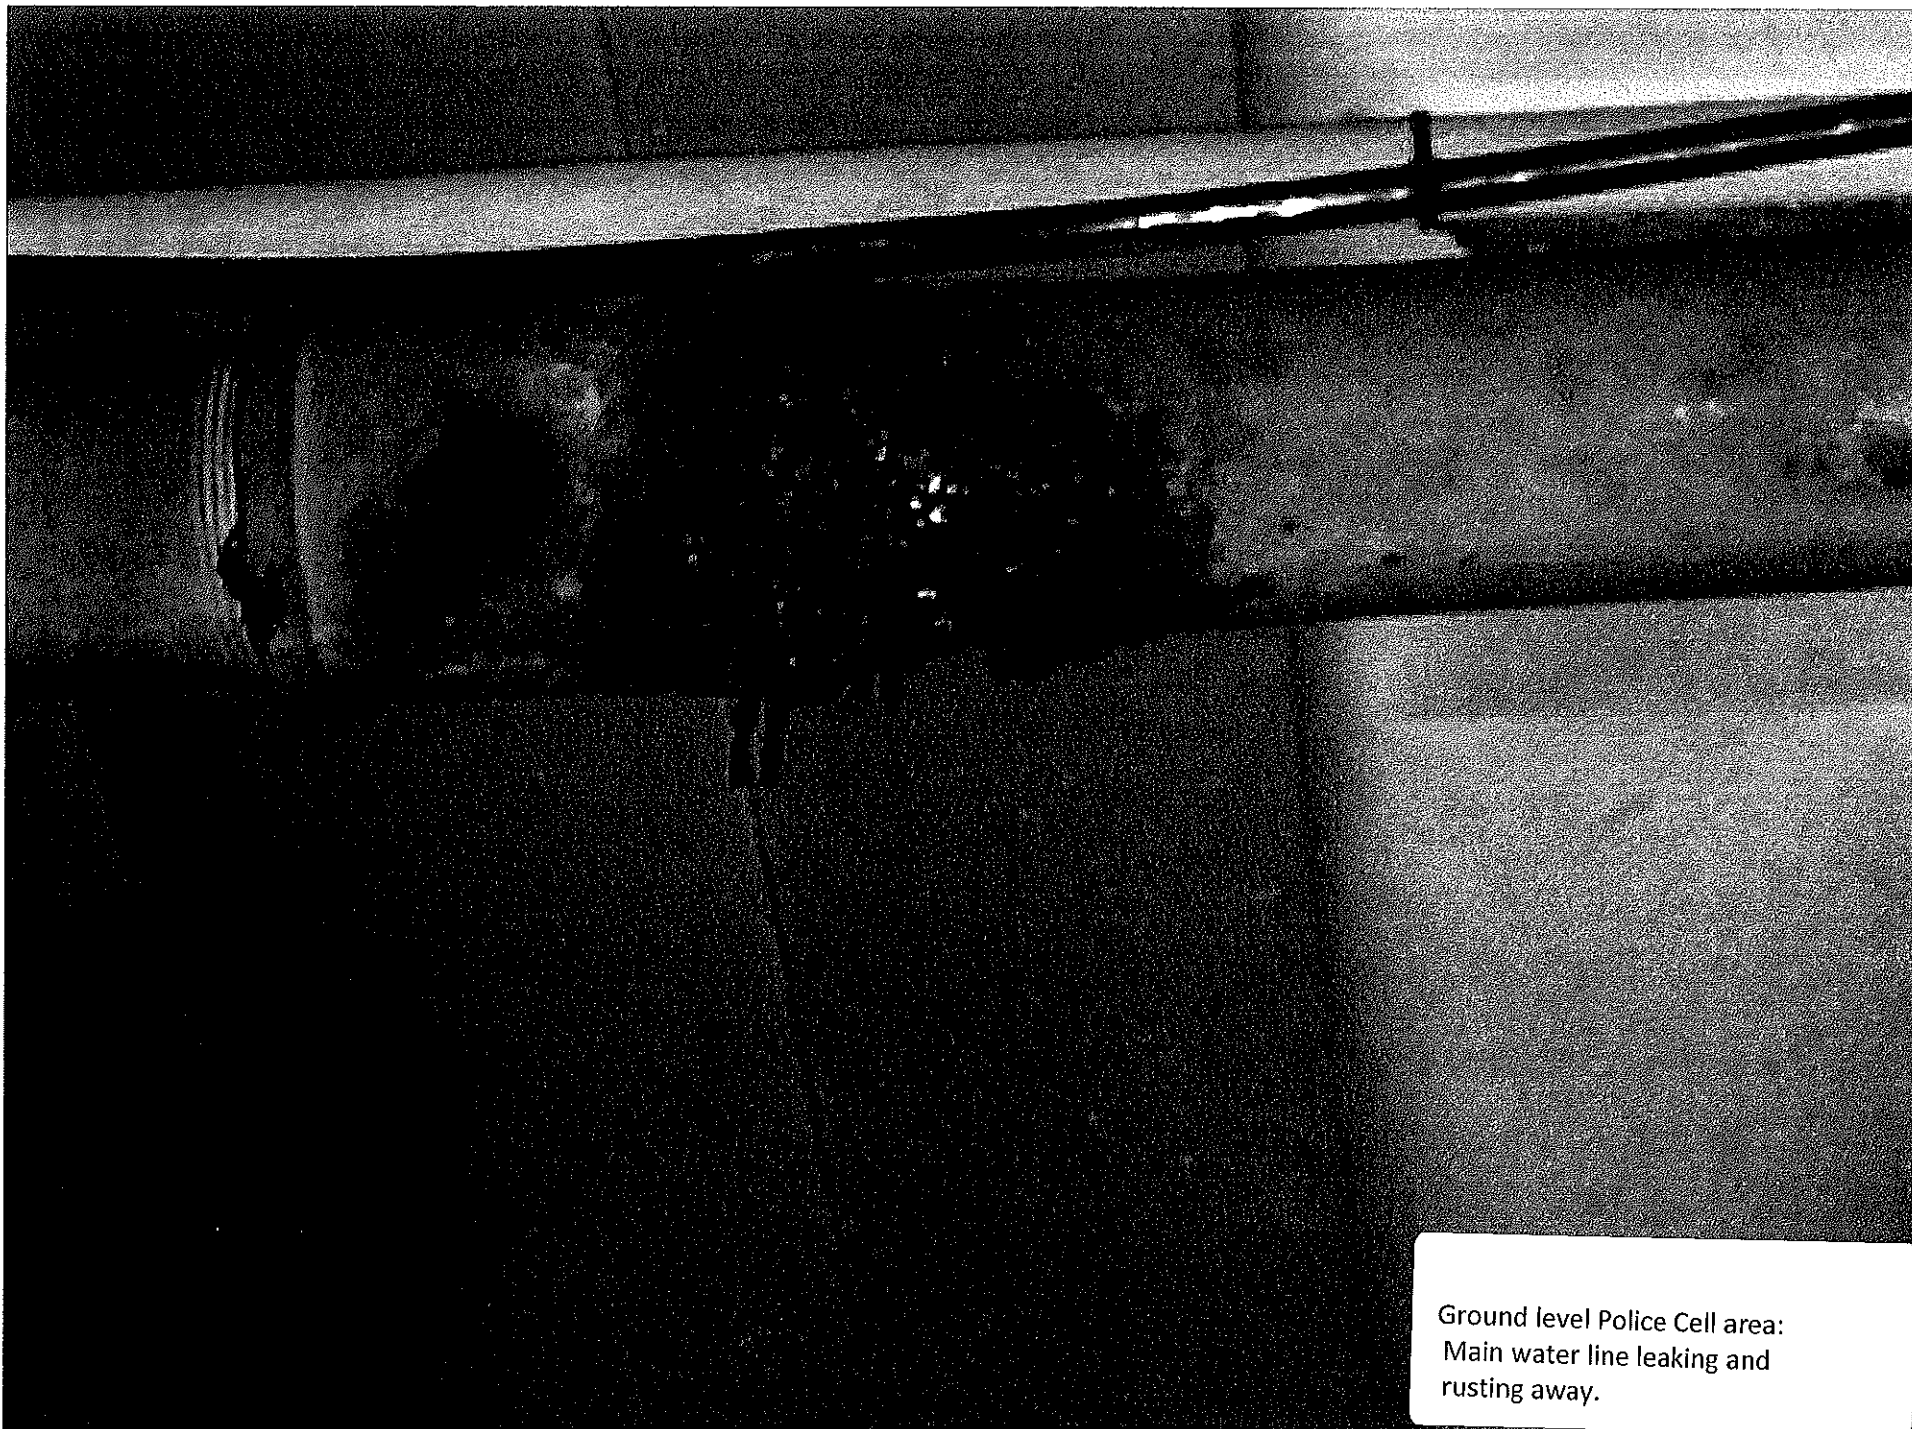
Ground level Police Cell area:
Main water line leaking and
rusting away.

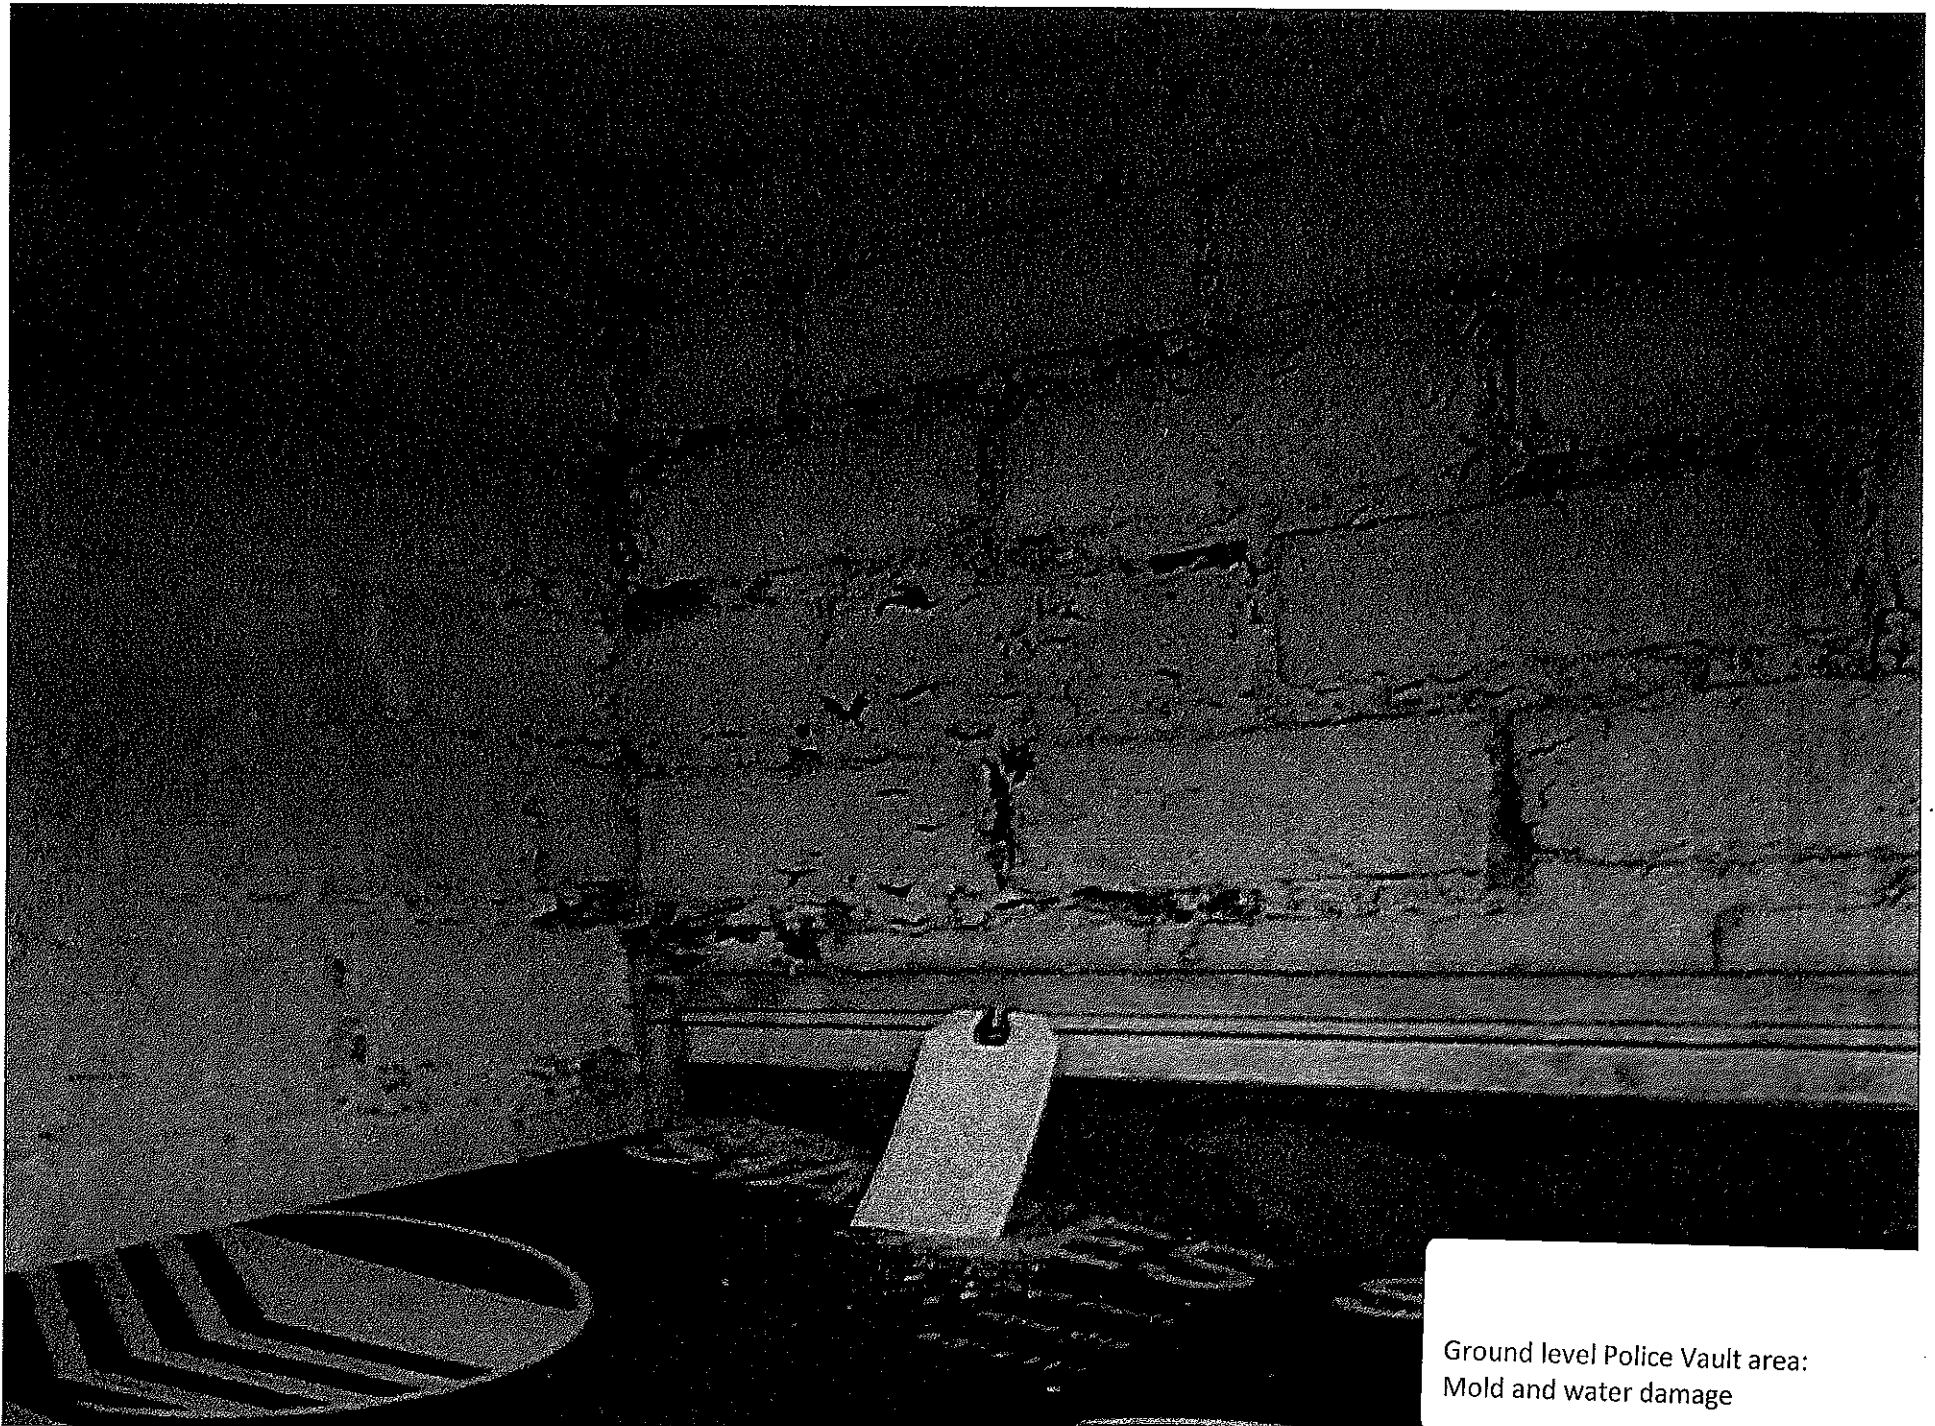
Ground level Police Vault area:
Mold and water damage
